Manhole Inspection Summary

Manhole # S55M__013MH

Location Address: **901 baylis st**

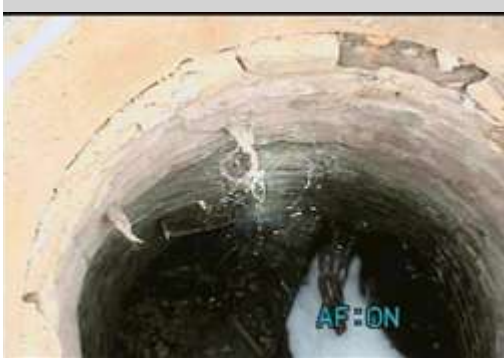
Defect 1

Condition: ☐ Sound ☐ Cracked ☐ Root Intrusion ☒ Loose Brick ☒ Deteriorated

Steps Count: **3** Missing: **2** ☒ Corroded

loose bricks corbel, missing&corroded steps

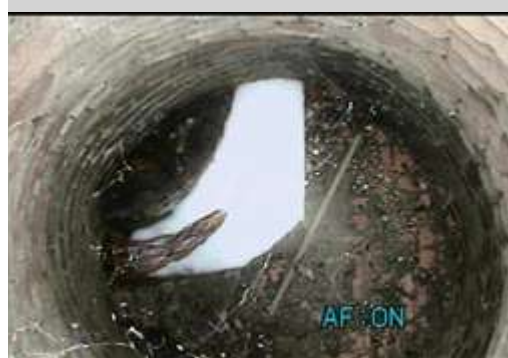
Defect 2

Condition: ☐ Sound ☐ Cracked ☐ Root Intrusion ☐ Deteriorated ☐ Leaks ☒ Debris

Bench Debris

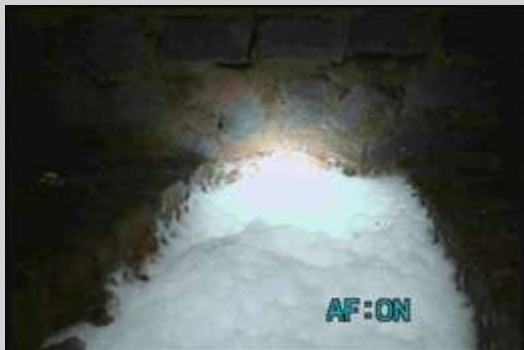
12 O'Clock Outflow

8 in. Circular Gravity Sewer
Pipe Out @ 12 O'Clock

Pipe Material: **Clay** ☐ Pipe Lined

Invert Depth: 7.50 (ft.) Flow Characteristics: **Fast**

Infiltration: **None** Pipe Seal Cond: **Unknown**

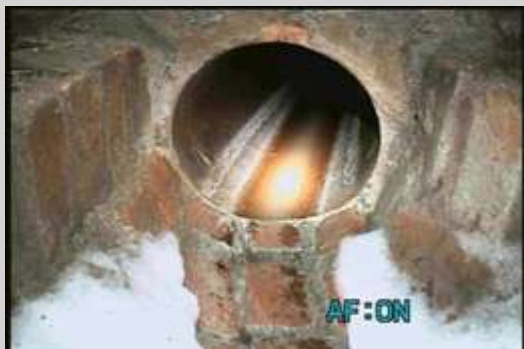
9 O'Clock Inflow

8 in. Circular Gravity Sewer
Pipe In @ 9 O'Clock

Pipe Material: **Clay** ☐ Pipe Lined

Invert Depth: 7.20 (ft.) Flow Characteristics: **Fast**

Infiltration: **None** Pipe Seal Cond: **Unknown**
